Home Report

Banks
Ruthven
Huntly
AB54 4ST

Single Survey and Mortgage Valuation Report

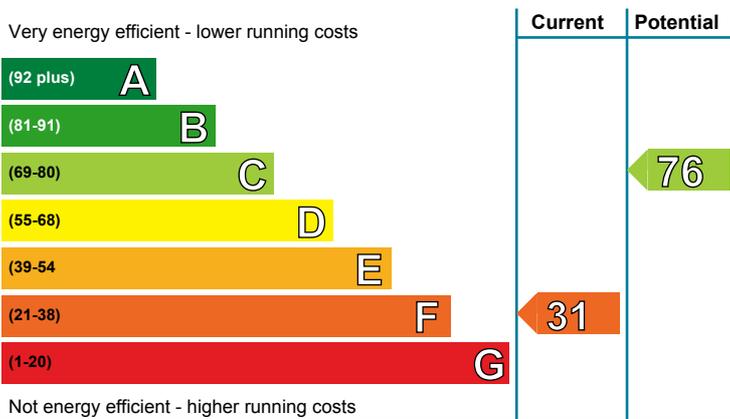
Energy Efficiency Rating

This graph shows the current efficiency of your home, taking into account both energy efficiency and fuel costs. The higher this rating, the lower your fuel bills are likely to be.

Your current rating is **band F (31)**. The average rating for EPCs in Scotland is **band D (61)**.

The potential rating shows the effect of undertaking all of the improvement measures listed within your recommendations report.

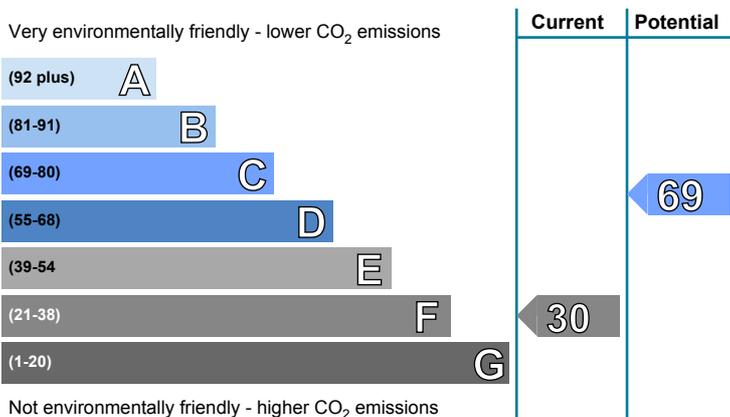
Environmental Impact (CO₂) Rating

This graph shows the effect of your home on the environment in terms of carbon dioxide (CO₂) emissions. The higher the rating, the less impact it has on the environment.
